Stone, Mortar & Window Leak Inspection Trinity United Methodist Church September 14, 2013

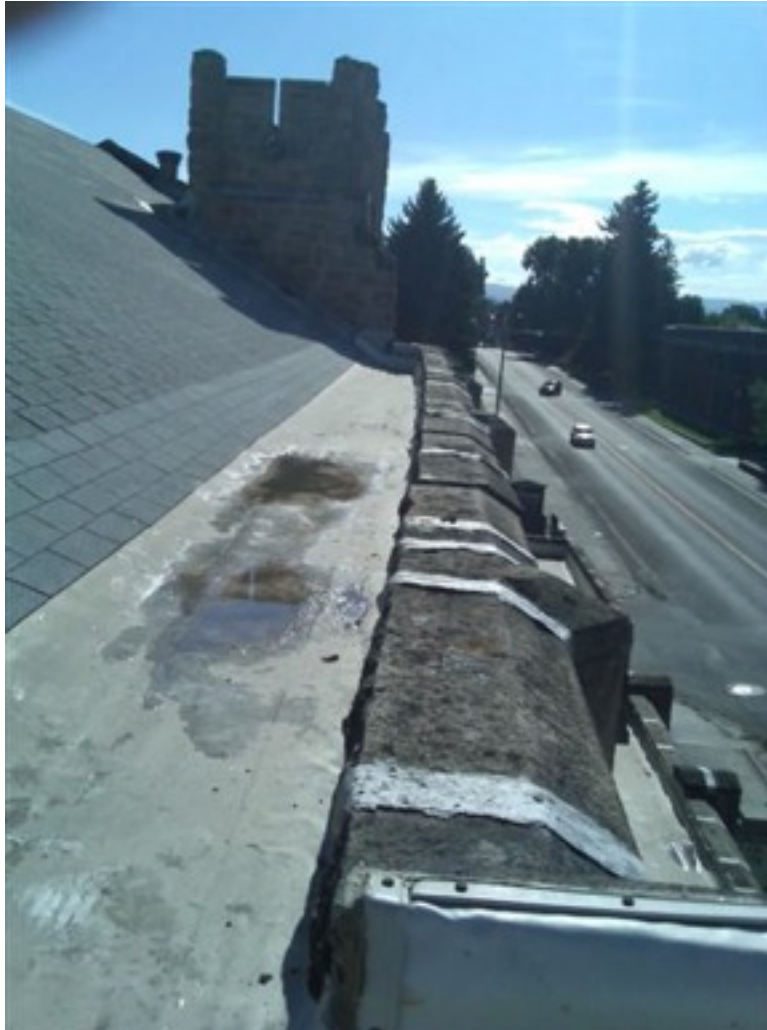
While checking the parapet wall on the south clerestory, the mason observed a possible bow in the wall (see Photo 1). The center buttresses appear to have an outward displacement estimated 1 to 3 inches, although the inspection team lacked appropriate tools to confirm this observation. No cracking or settling was observed in the stone or masonry, so it's uncertain if this condition has existed since the construction of the building.

Photo 1: View of south clerestory parapet wall showing possible outward bow.
